INFORMATION FROM THE INVESTIGATING OFFICERS REPORT OF MOTOR VEHICLE ACCIDENT

Case Number:	16-000200	Report to All Drivers:	NO	At Intersection with:	"N/A"
Date of Acc:	01/07/16	Legal Intervention:	NO	Div HWay Trvl Dir:	"N/A"
Time of Acc:	08:21 Hrs.	Private Property:	NO	Distance 1:	"N/A"
Name of Agency:	PLYMOUTH COUNTY SHERIFF'S OFF	County:	PLYMOUTH - 75	Direction 1:	"N/A"
Officer:	SINGER RICK	Acc Loc City:		Distance 2:	"N/A"
Badge #:	75-4	Acc Dir From City:	"N/A"	Direction 2:	"N/A"
Report Date:	01/07/2016	Closest City:	"N/A"	X-Coordinate:	00218770
Officer Notified:	08:21 Hrs.	Miles From City:	"N/A"	Y-Coordinate:	04725127
Officer Arrived:	08:47 Hrs.	Road,Street,HWay:	"N/A"	Location Literal Description:	K019/SOUTH RIDGE RD AND C060/C60
Scene Investigated:	YES	Definable Location:	"N/A"		
		Milepost Number:	"N/A"

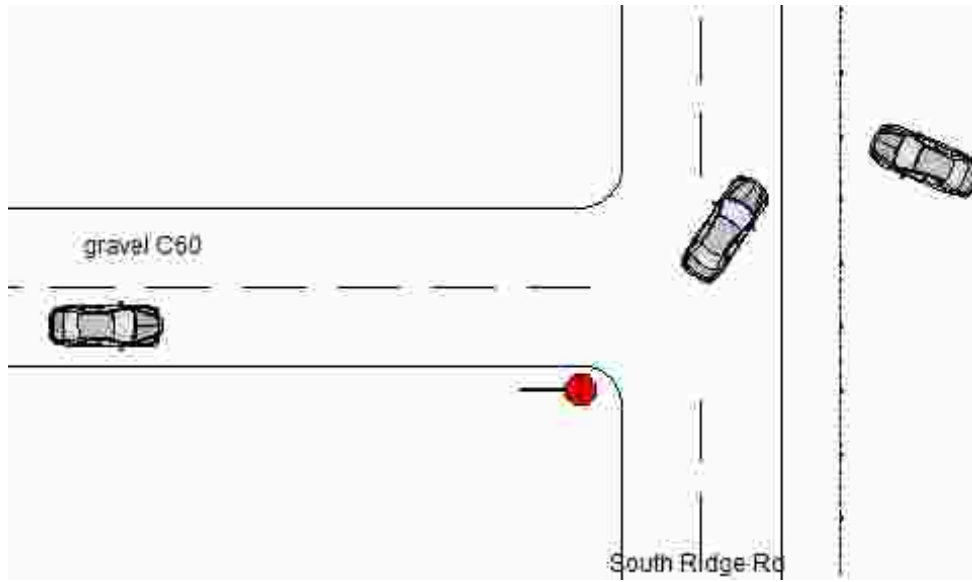
Diagram

Vehicle #1 was east bound on gravel C60 approaching South Ridge Rd operating in dense fog. Roadways at the time were snow and ice covered. Driver of vehicle #1 stated that his GPS told him he was .2 miles from the intersection. Driver of vehicle #1 stated that when he was able to see through the fog he was at the corner and could not stop due to the road conditions. Driver of #1 attempted to make the left hand turn, entered the ditch rolling one time coming to rest

on the wheels. Driver of #1 suffered a leg injury from a fence post coming into the vehicle while rolling.
